# TALBOT MILLS DAM REMOVAL / CONCORD RIVER ECOLOGICAL RESTORATION PROJECT

HISTORIC DISTRICTS COMMISSION SUPPLEMENTAL  
INFORMATION TO APPLICATION

***TALBOT MILLS DAM***  
**PHASE I**  
**INSPECTION / EVALUATION REPORT**

Dam Name: *Talbot Mills Dam*

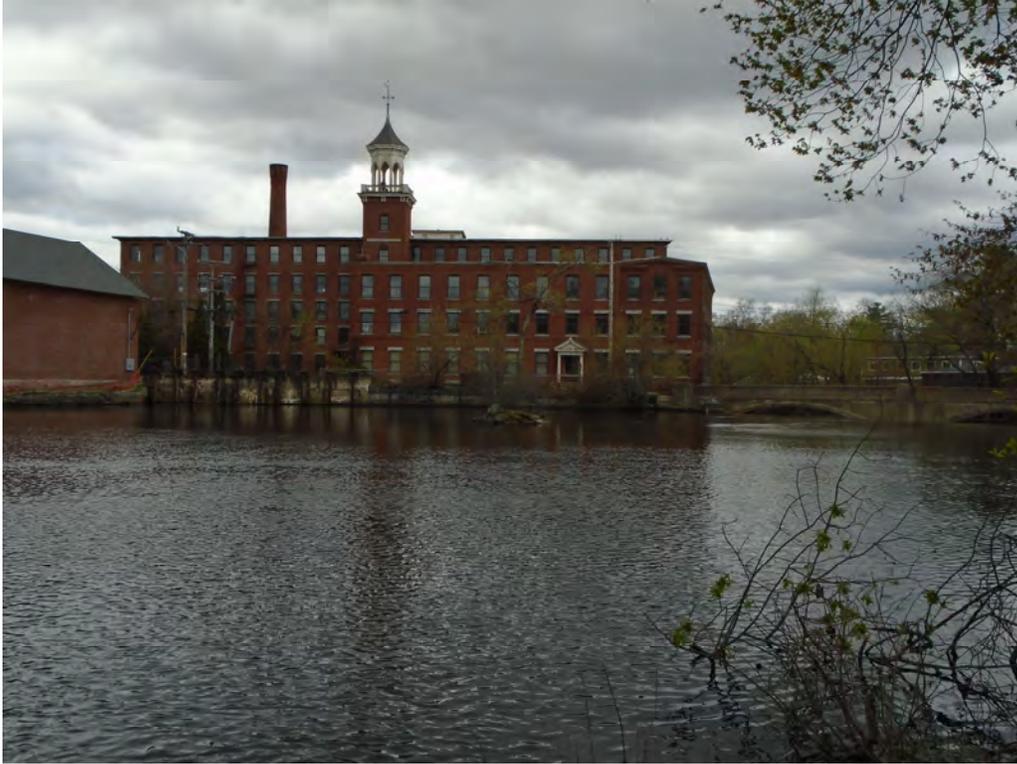
**Photograph 1. Overview of Talbot Mills Dam Looking Downstream**

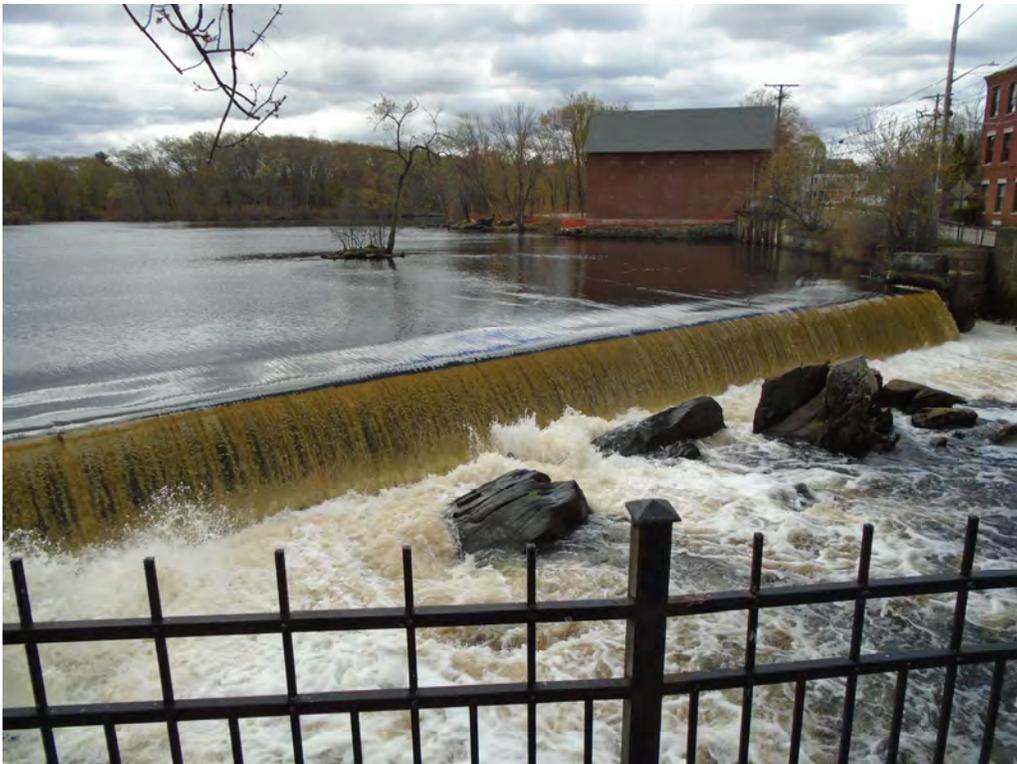
**Photograph 2. Overview of Talbot Mills Dam Looking Upstream**

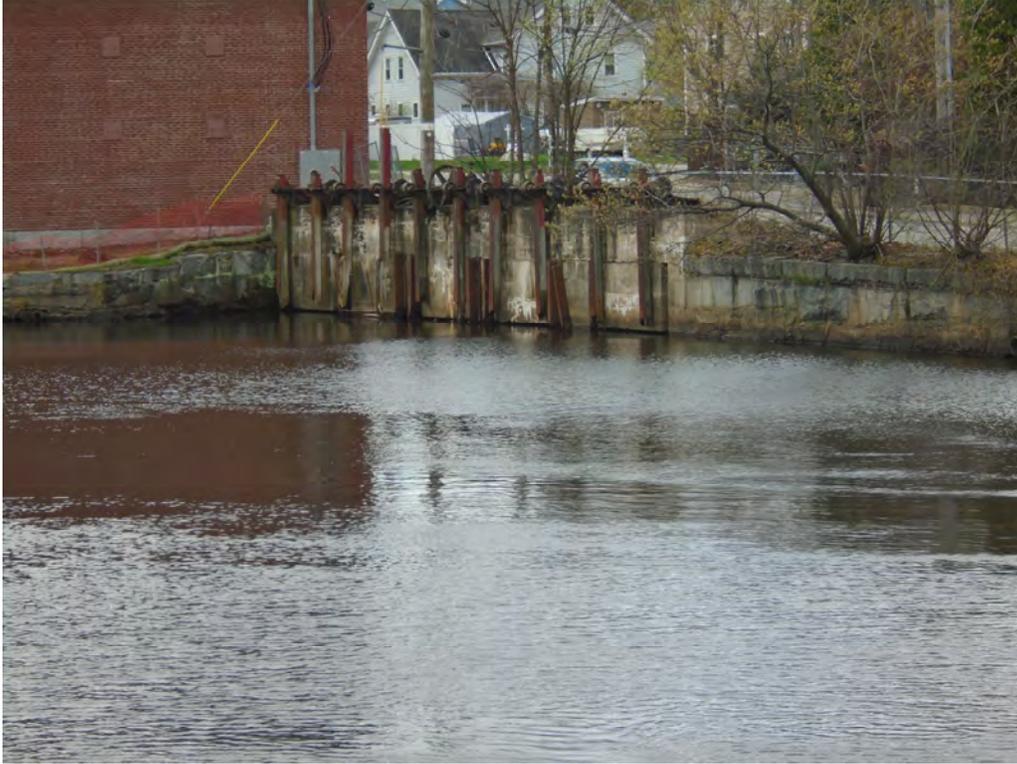
**Photograph 3. Concrete Wall and Intake Gates Left of Spillway**

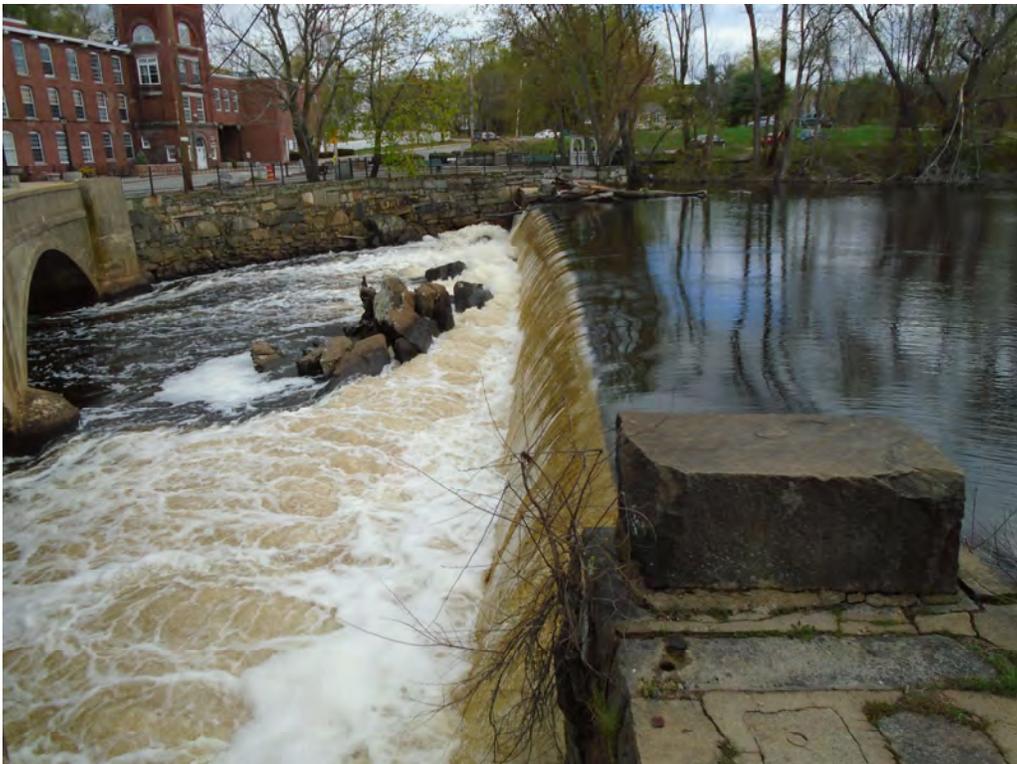
**Photograph 4. Downstream of Spillway Viewed from Left Abutment**

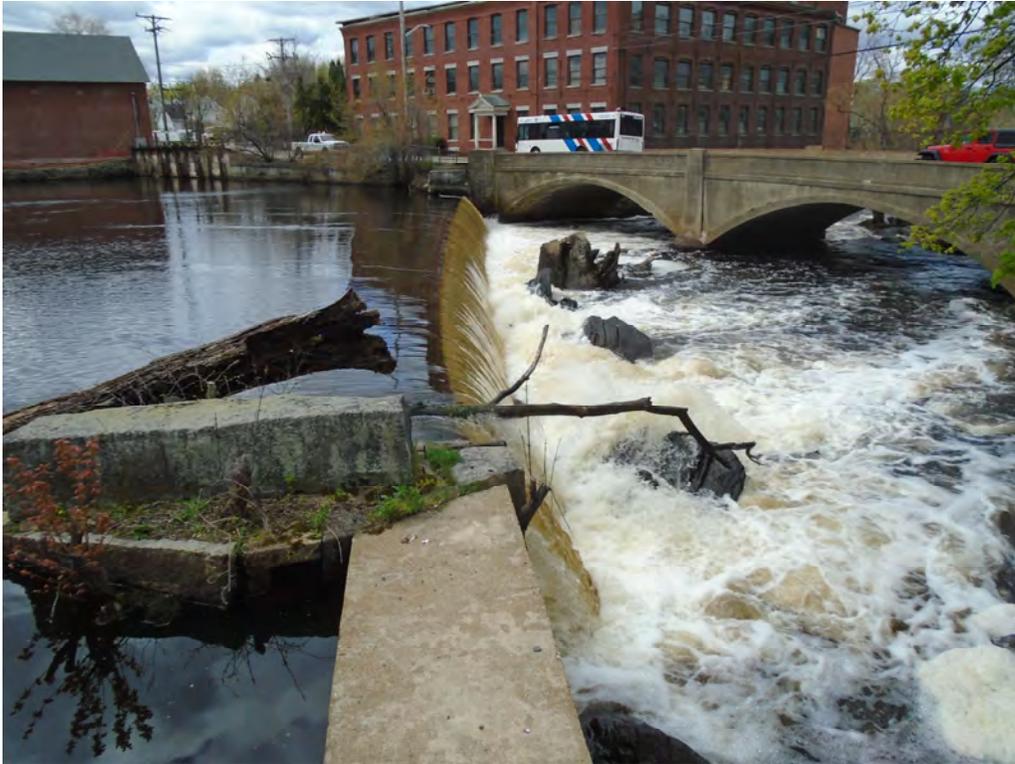
**Photograph 5. Downstream of Spillway Viewed from Right Abutment**

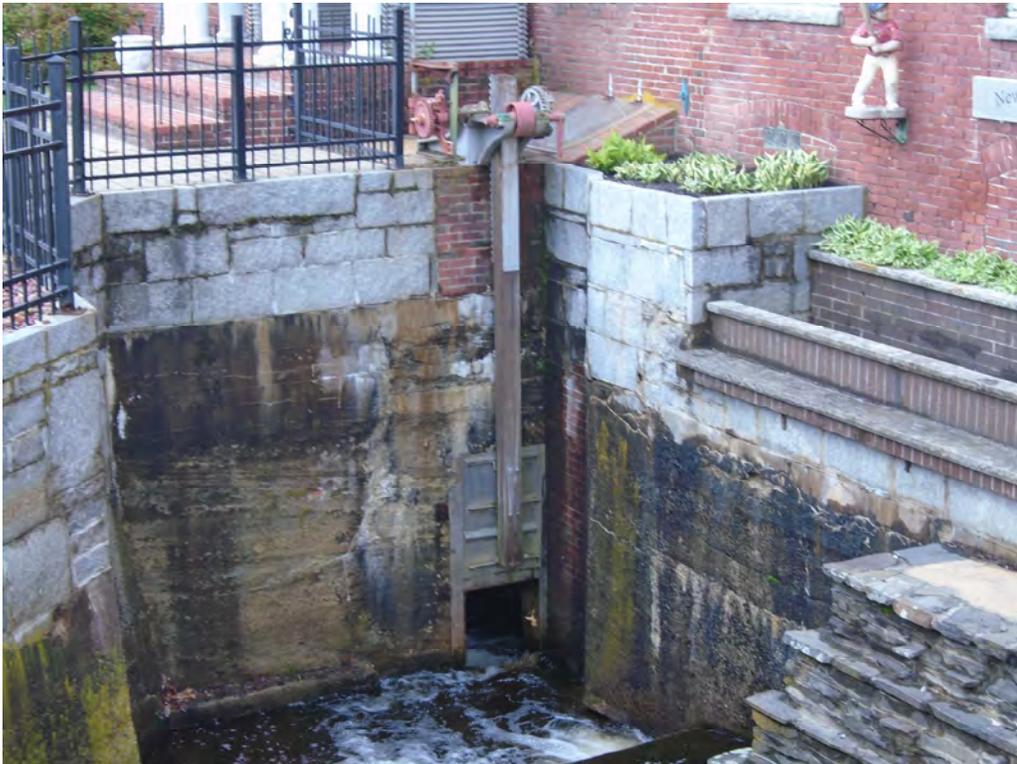
**Photograph 8. Stilling Basin with Outlet Gate Locked in Open**

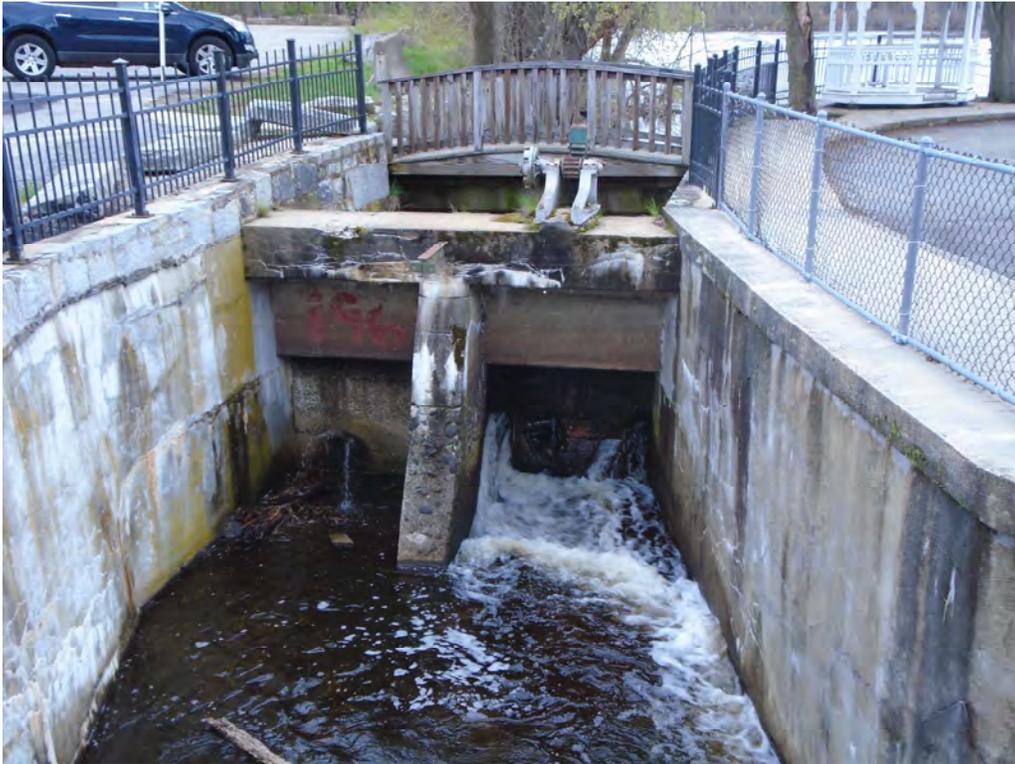
**Photograph 9. Sluiceway with Movable Gate and Concrete Weir**

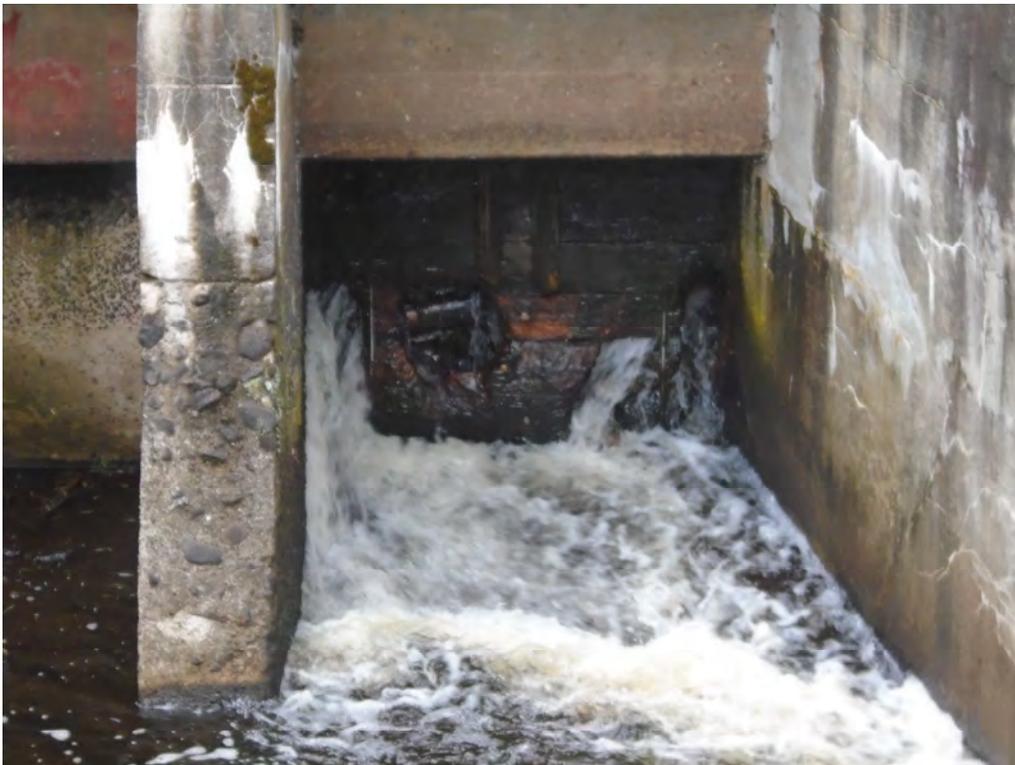
**Photograph 10. Water Seepage Through the Sluiceway Gate**

- Repair/replace the sluiceway and stilling basin gates so that the gates are operational and can provide emergency bypass control.
- Inspect the interior of the Talbot Mills complex, particularly the downstream end of the former intake structures. The infilling of the intake tunnels on the left side of the dam rendered these intakes inoperable. Given the configuration of the dam, proximity of the mill complexes, and changing ownership of the downstream properties, the reconstruction of a low-level outlet in this area is impractical.
- Repair/replace the left spillway abutment to provide an operational low-level outlet and emergency bypass control.

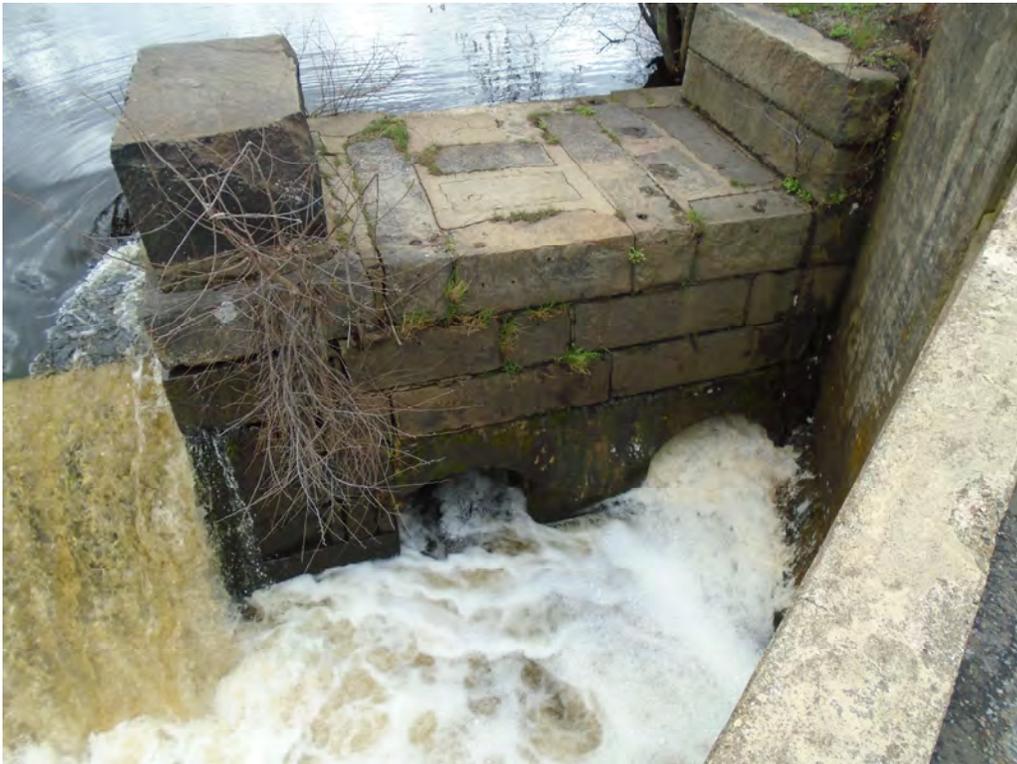
**Photograph 12. Lower Level Outlet at Left Spillway Abutment**
