# TALBOT MILLS DAM REMOVAL / CONCORD RIVER ECOLOGICAL RESTORATION PROJECT

HISTORIC DISTRICTS COMMISSION SUPPLEMENTAL  
INFORMATION TO APPLICATION

***TALBOT MILLS DAM***  
**PHASE I**  
**INSPECTION / EVALUATION REPORT**

Dam Name: *Talbot Mills Dam*

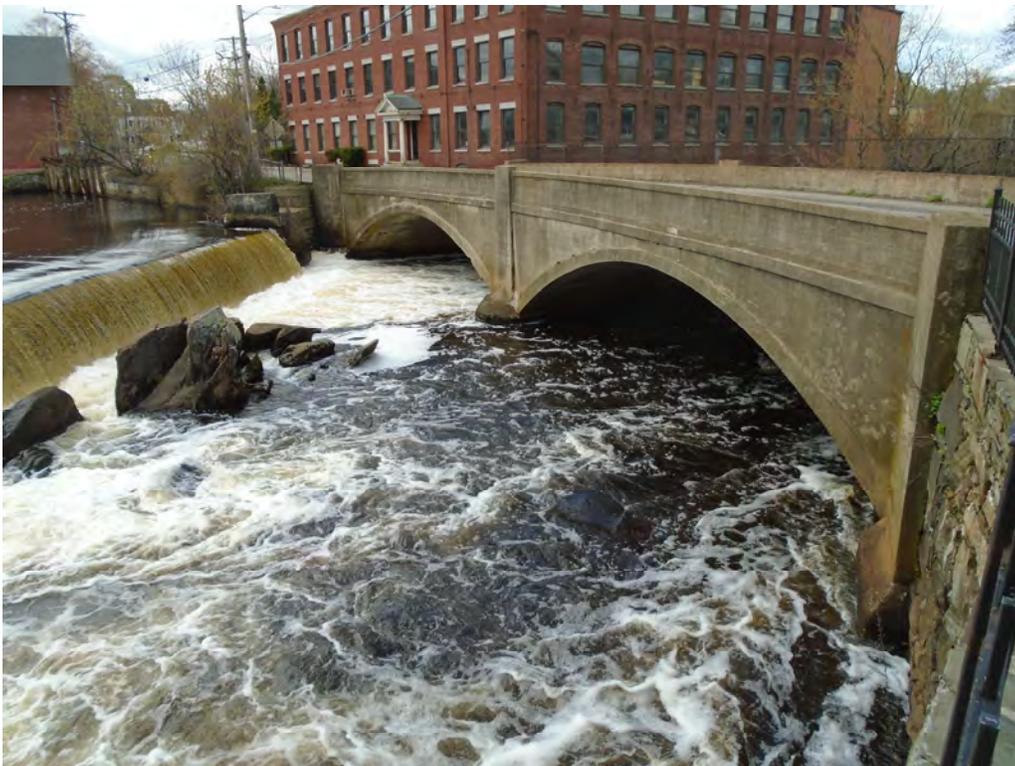
Located immediately downstream from the primary dam spillway is the Faulkner Street Bridge. Having a width of approximately 32 feet, the bridge carries two lanes of vehicle traffic and a pedestrian sidewalk on the west (downstream) side only. The curved concrete arch bridge has an overall length of approximately 120 feet. Each individual span of the dual span concrete arch is approximately 42 feet long at the base. It appears the center pier and abutment footings are armored and founded directly on the bedrock. The bridge can be seen in Photograph 6.

**Photograph 6. Falkner Street Bridge Viewed from Right Abutment**

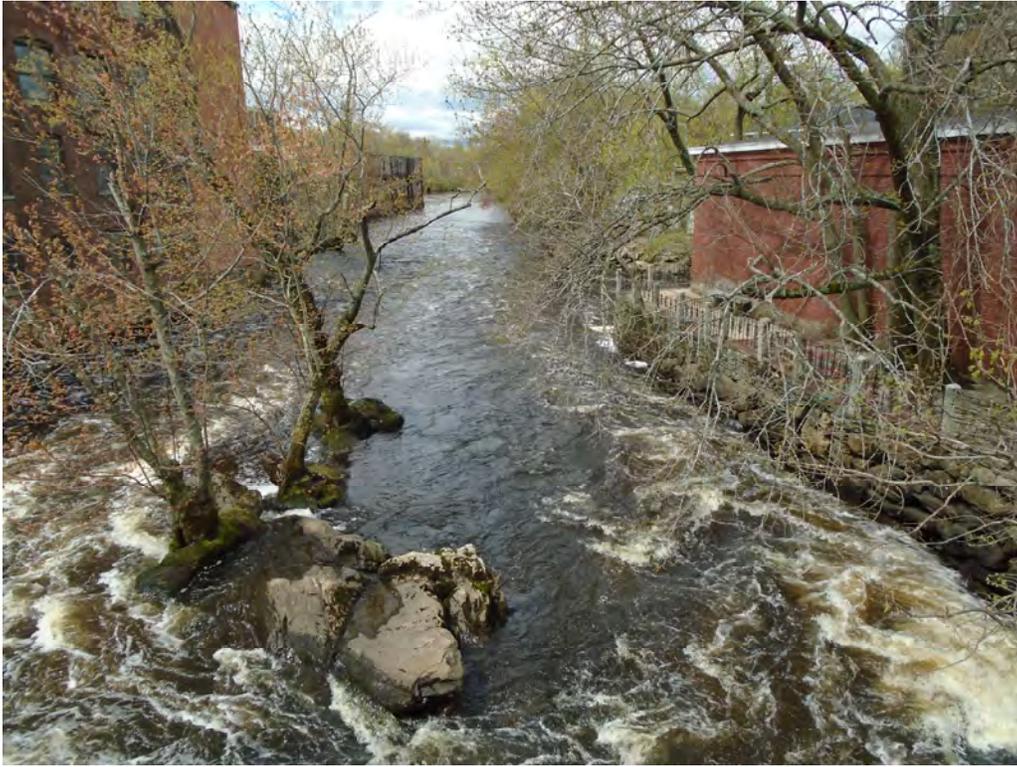
**Photograph 7. Downstream Channel Viewed from Falkner Street Bridge**

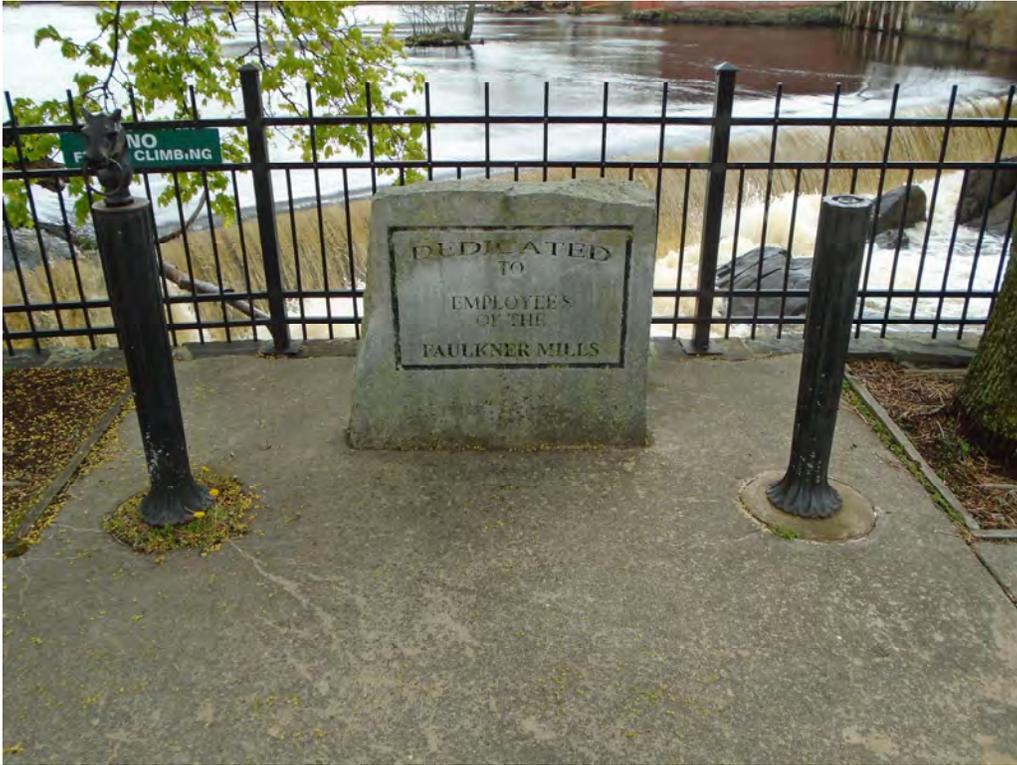
shown in Photograph 11. Access to the park is available from a paved parking lot just east of the river and south of Faulkner Street by crossing a pedestrian bridge over the sluiceway.

**Photograph 11. Historic Marker Dedicated to the Employees of Faulkner Mills**

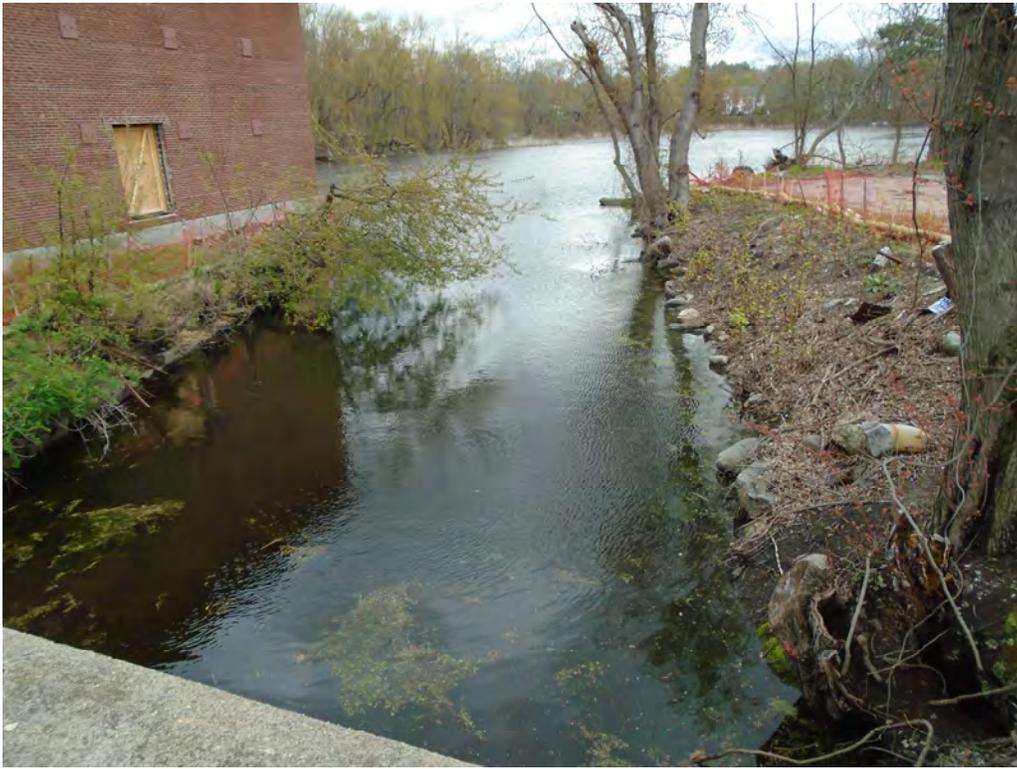
Further to the south, a stone wall serves as a training wall. The top of the training wall ranges between elevation 112.2 and elevation 114.9 feet. Grades behind the wall slope slightly upward to the old Middlesex Canal Building. Remnants of the old Middlesex Canal alignment are located to the south of the building as shown in Photograph 13.

**Photograph 13. Alignment of Old Middlesex Canal**

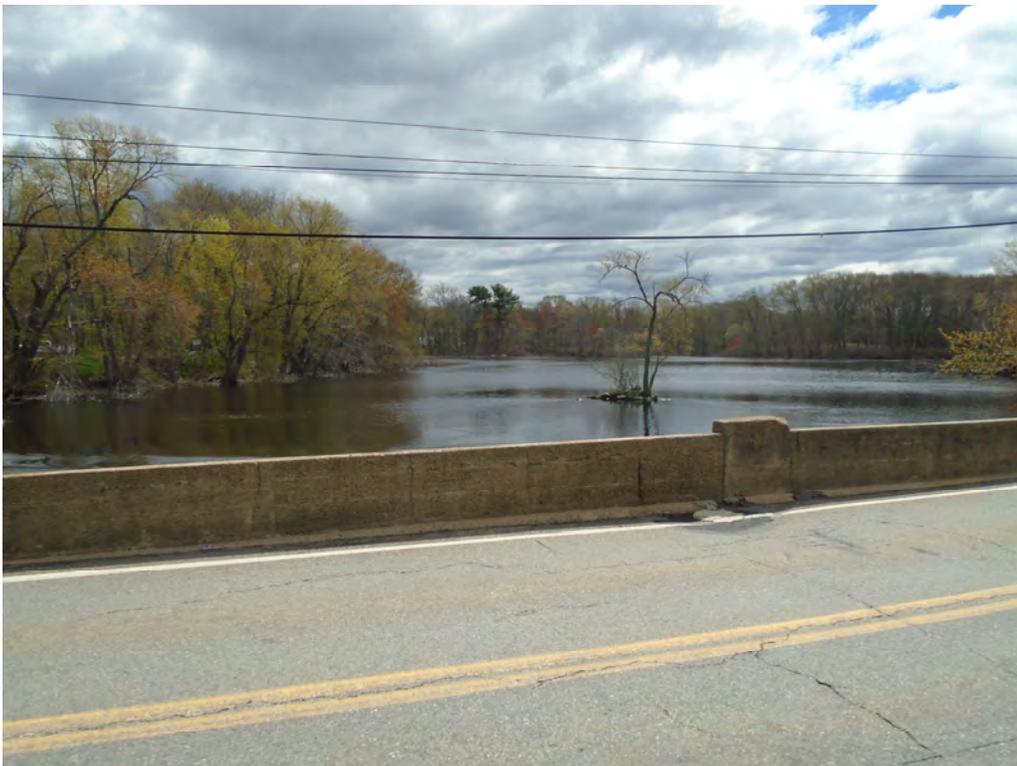
**Photograph 14. Overview of Reservoir**
